*Research article*

## SEISMIC VULNERABILITY ASSESSMENT OF EXISTING BUILDINGS BY RAPID VISUAL SCREENING METHOD: A STUDY ON WARD 27 IN DHAKA SOUTH CITY CORPORATION

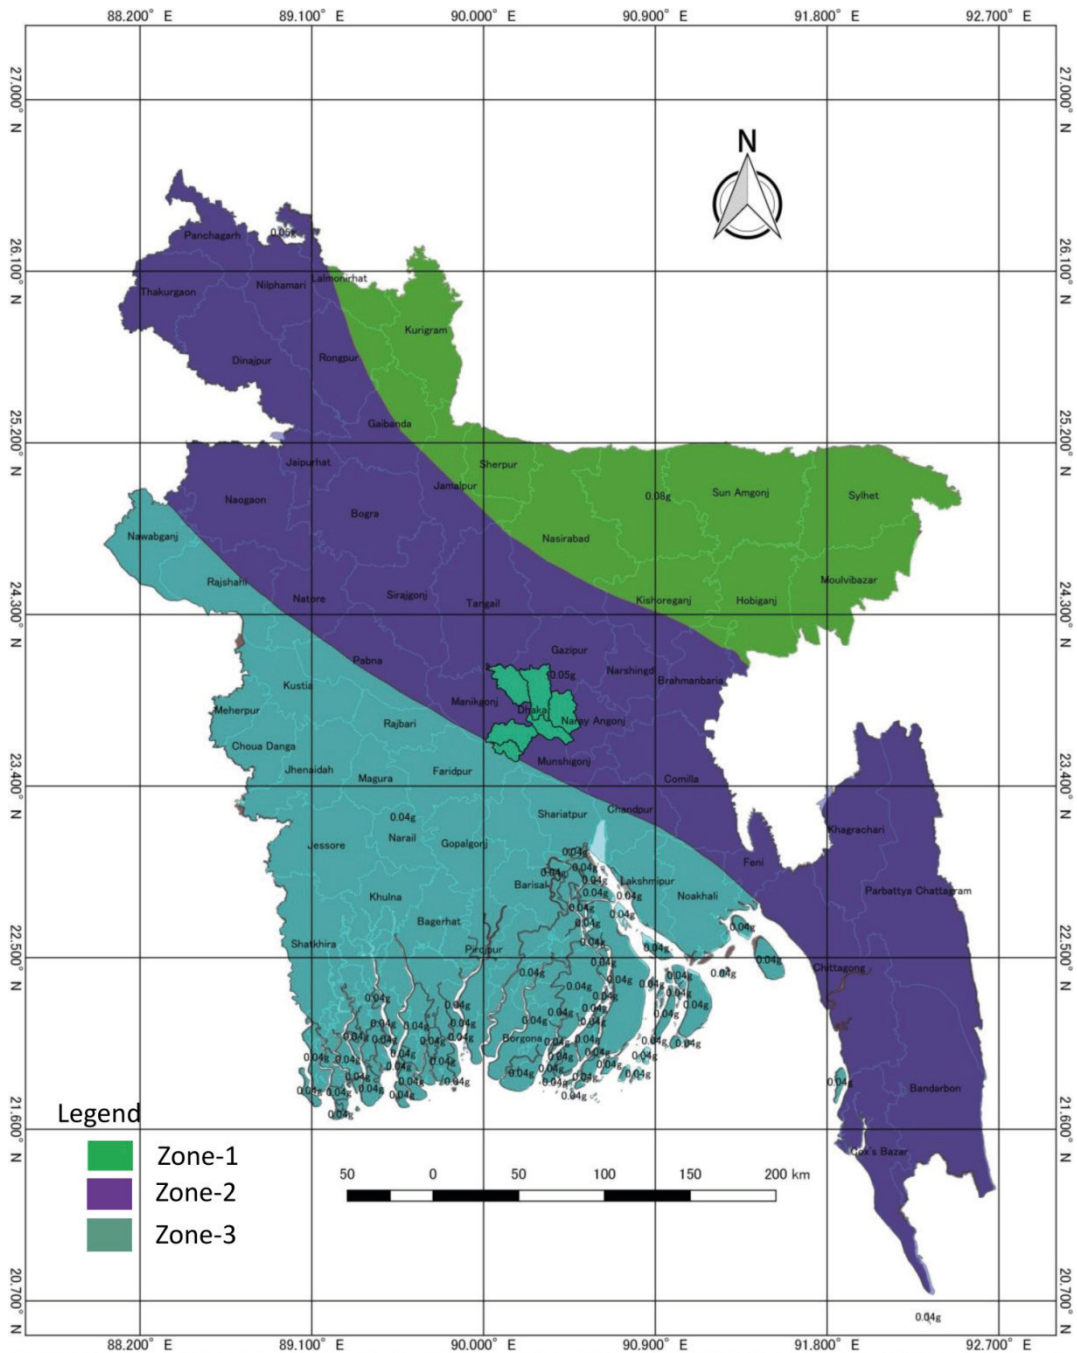
Figure 1. Zones at risk from earthquakes in Bangladesh (BNBC-1993).

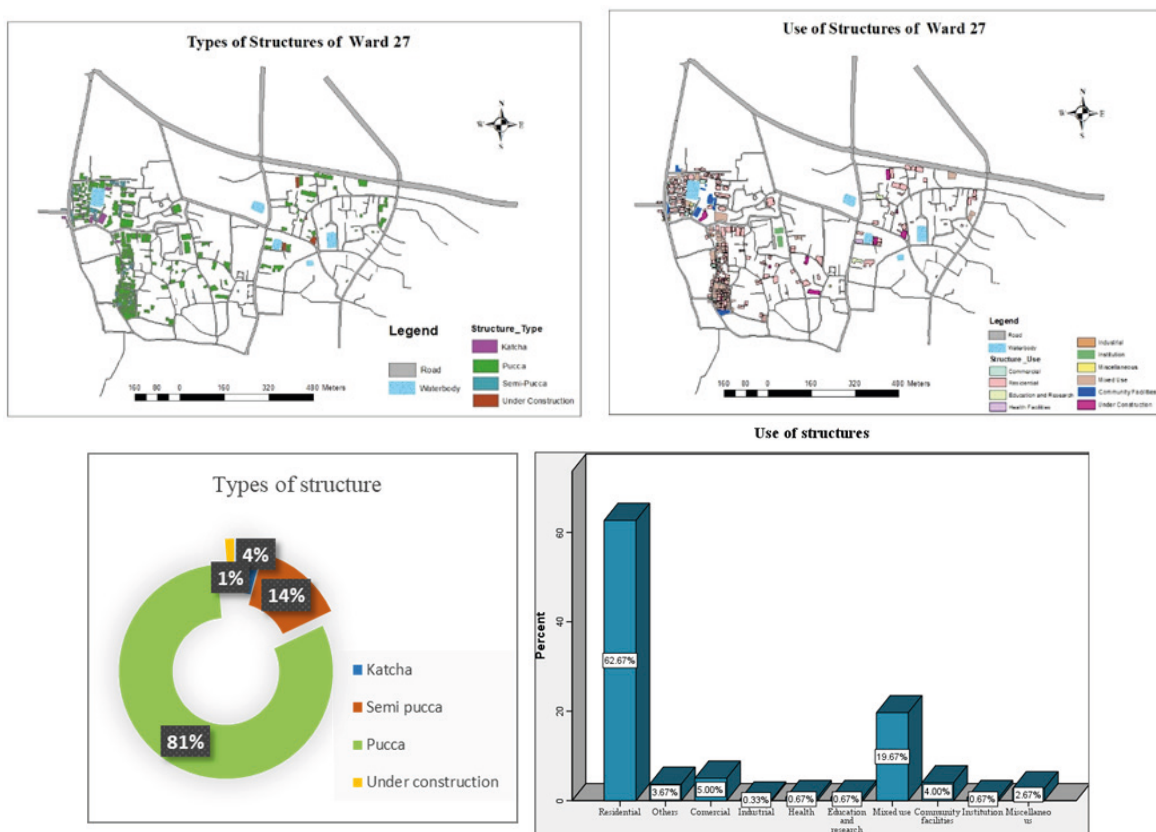
Figure 3: Types and uses of selected structures of ward no. 27

The study area consists primarily of pucca structures, which are approximately 80.67 percent. The other types included Semi pucca 13.67%, katcha 4.33% and under construction are about 1.33% of all buildings. According to RAJUK (2015), about 59.63% of buildings are residential and 16% are for mixed use. The shape file shows that 62.67 percent of buildings are solely for residential use. Commercial and commercial apps account for 5% and 3% of overall applications, respectively. Public facilities, which mostly include mosques, cultural centers, and clubs, account for 4%; education and research account for 1.67 percent; and mixed use accounts for 19.67 percent.

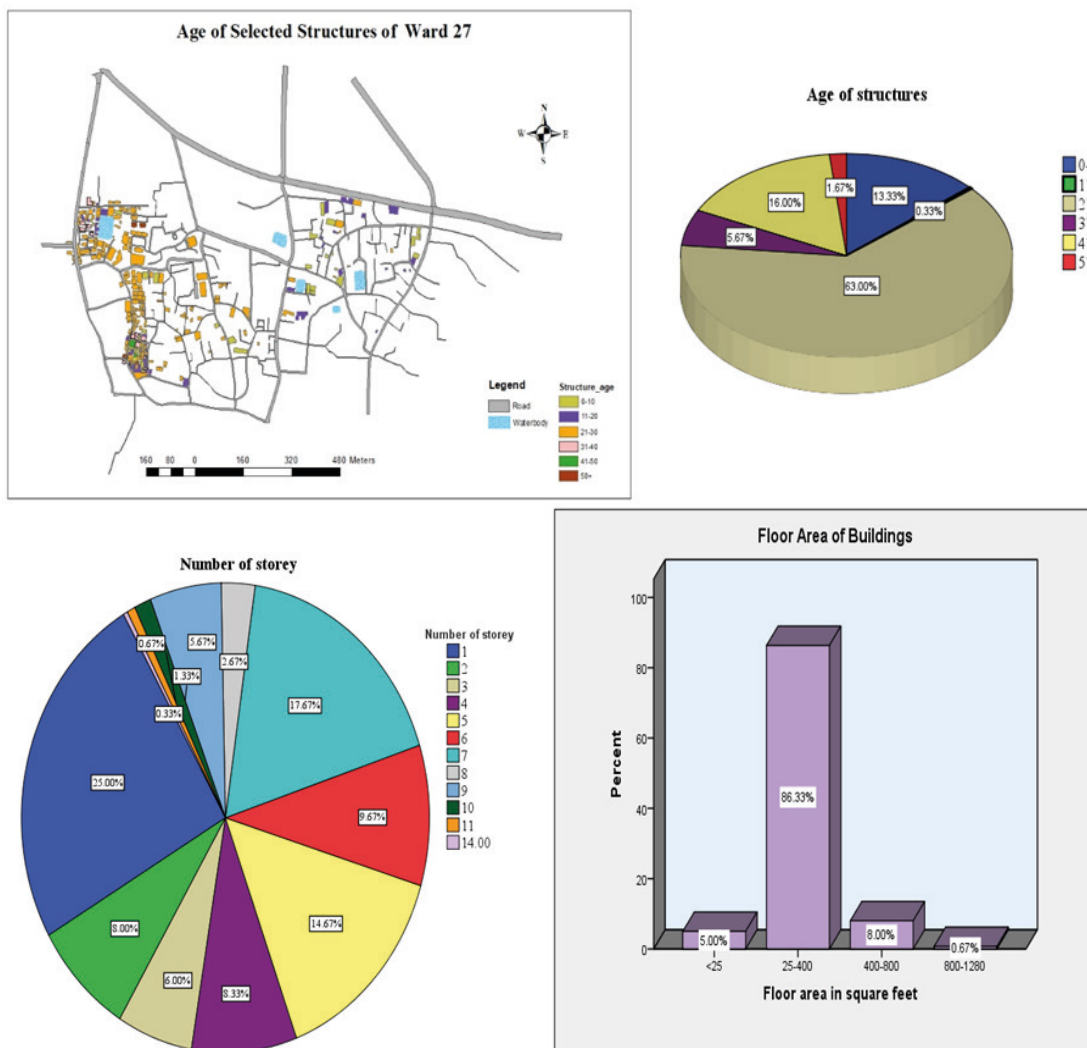
**Figure 4:** Age, number of storey and floor area of selected structures of ward no. 27

Due to the exponential growth of the population, the majority of the current structures have recently been demolished and reconstructed. 33 percent of structures were constructed 11 to 20 years ago, 63 percent were constructed 21 to 30 years ago, 5.67 percent were constructed 31 to 40 years ago, 16 percent were constructed 41 to 50 years ago, and 1.67 percent was constructed 51 to 60 years ago. Figure shows distribution of age of buildings.

When RAJUK (2015) data was compared, it is observed that the proportion of one-story buildings declined from 71.74 percent to 25%, whereas the proportion of four-story, five-story, and six-story buildings increased significantly. Buildings of 7, 8, 9, 10, and 11 floors were also added. The research area has expanded vertically as vacant land has become scarce and population and economic growth have increased.

The building owners in the sample area do not follow the RAJUK Building Construction Law. As a result, the building's floor size is almost equal to the number of floors in this ward. The plot's total land area is equivalent to the floor space of the house. The floor space varies from 25 square feet to 1280 square feet. The bulk of the buildings (86.33 percent) have a residential floor space of 25-400 square feet. Buildings with a surface area of 400-800 square feet, mostly commercial shops and shantytowns, account for 8.67 percent of the total

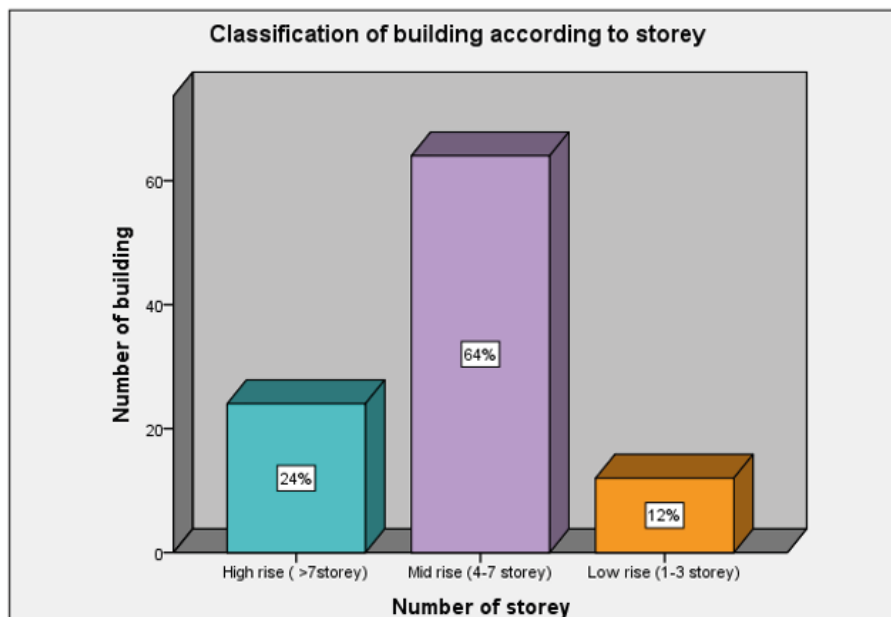
Figure 6: Distribution of buildings according to number of storey

From the field survey 2020, it is evident that 24% of buildings are >7 storey, 64% of buildings are 4-7 storey and 12% of buildings are 1-3 storey.

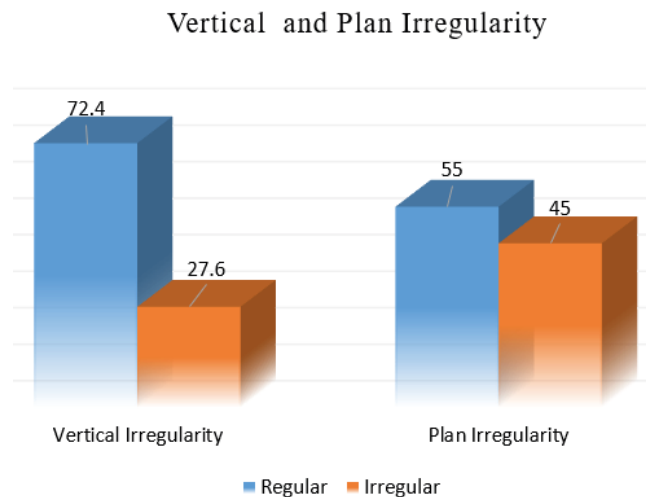
**Figure 7:** Vertical irregularity and plan irregularity of buildings.

From the field survey, it is found that 27.6% of buildings in the region are vertically irregular and 72.4% buildings are vertically regular. About 55% of the sample buildings have a regular shape (square or rectangular) and 45% of buildings are found to have irregular (T-shaped, L shaped, etc.).

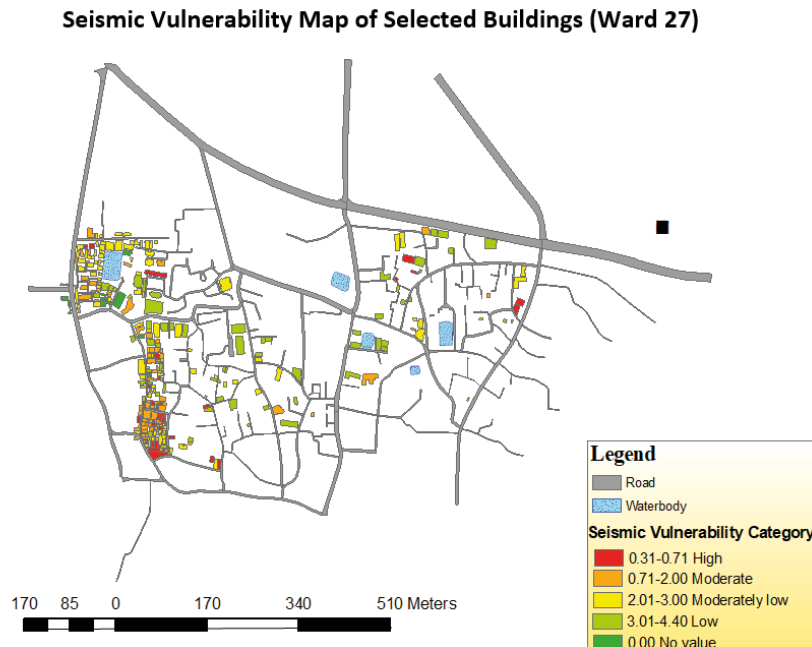
**Figure 8:** Seismic Vulnerability Map of Selected Buildings (Ward 27)

Among 300 surveyed buildings, 13 katcha structures (4.33 percent) are found to be out of scoring due to their construction materials among the 300 surveyed buildings. About 23 percent of buildings received a score of 3.01 to 4.4, 35 percent received a score of 2.01-3.0, and 25.67 percent received a score of 0.71-2.0 where 12% of the structures were scored 0.31.70. The Figure 8 shows seismic vulnerability scenario in the study area.
